CASE STUDY
Turbine rub damage

Early detection of ITT and N2 trend changes lead to prompt and cost efficient repair with minimum operation disruption.

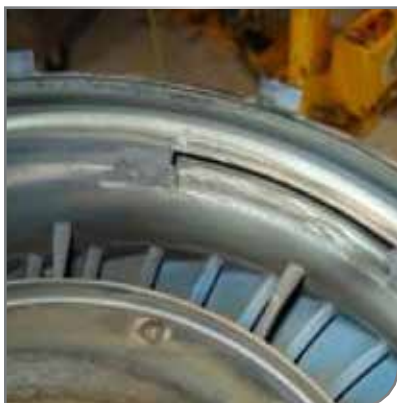
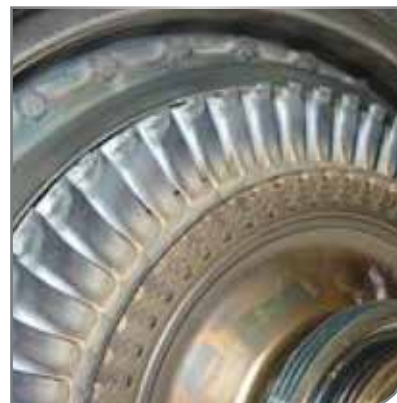
We observed a rapid increase in ITT of almost 60°C and a decrease in N2 of around 3.5% on the #1 Engine over the last four flights of the download data. We strongly recommended that the customer investigate this change as a matter of urgency as this type of trend could indicate genuine engine hot end deterioration.

The aircraft was ferried to a maintenance shop for investigation. Turbine entry found High Pressure shroud failure with heavy secondary damage caused by debris.

The operator was provided with the information to enable it to schedule the repair. Without this information the aircraft may have become grounded due to performance issues during a scheduled flight, ending in passenger disruption, high costs of shipping and staff movements to replace the engine.
