CASE STUDY

Bleed air leaks on Citation III

Highlighted increase in engine ITT, Inter-Turbine Temperature, leads to early correction.

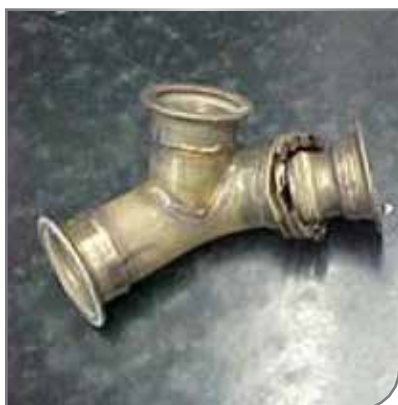
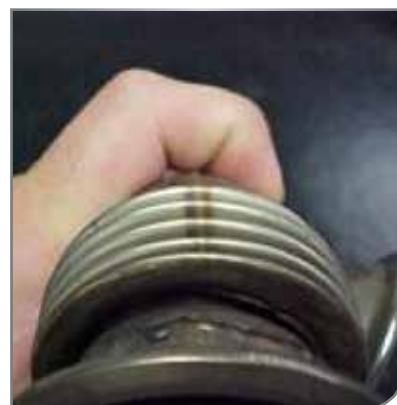
Further to our advisory e-mail (kneepad data), an earlier telephone conversation and our customer's DEEC download, we confirmed a significant increase of #1 Engine ITT (+15C).

The customer discovered a severe bleed air leak in the HP system, corrected all leaks and performed five point runs. The aircraft engine temperatures were well within limits and the #1 Engine was now actually running cooler than the #2. The bleed leaks were in the airframe pre-cooler assembly on top of the engine. There are some flexible bellows that attach the bleed airlines to the pre-cooler. Both of these bellows were leaking. One was completely blown out and the other was leaking around the seam weld. The pre-cooler itself was also leaking when it was pressure tested off of the engine. So both bellow lines and the pre-cooler were replaced. This brought the ITT back to well within limits.

Besides bringing the engine temperatures back to within limits, bleed leaks can, if uncorrected, cause extensive and expensive damage to engines, cowling and wiring.
